GOVERNMENT OF THE VIRGIN ISLANDS
DEPARTMENT OF HEALTH, DIVISION OF ENVIRONMENTAL HEALTH

WATER POLLUTION REPORT NO. 2

EFFECTS OF DREDGING IN WATER BAY, ST. THOMAS

November, 1969

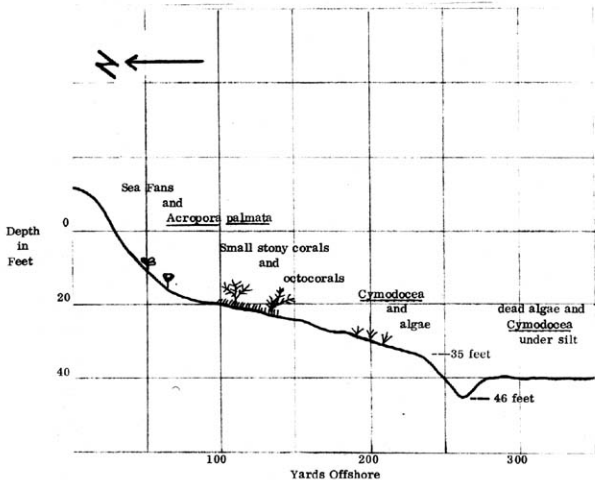
FIGURE 1
 WATER BAY, ST. THOMAS
 SKETCH OF SUBMARINE TRANSECT

Figure I is a cross section sketch of a line from about the tip of Coki Point southward into the dredged area. The bottom areas from Coki Point south for about 100 yards are floored with corals to a depth of approximately 25 feet. Below this coral zone is a narrow strip of sand with the grass Cymodocea and non-calcareous algae (e.g., Caulerpa). This grass community is interrupted by a distinct trench, made by the dredge, which roughly follows the contour of the point. The trench profile at the section line cuts into the slope below the reef at 30 - 35 feet depth; it is about 15 feet wide. The bottom of the trench is 46 feet and the level rises on the offshore side to 40 feet. The dredge cut described above was followed for about 1/4 mile underwater. For almost all of the length, it follows exactly a 28 foot depth contour. Presumably the dredge operator had control of this as the line followed extended at the constant depth first west, then north, then west, then south.
